# THE VANGUARD SATELLITE LAUNCHING VEHICLE - AN ENGINEERING SUMMARY \*

(Engineering Report No. 11022)

April 1960

THE MARTIN COMPANY, Baltimore, Md.

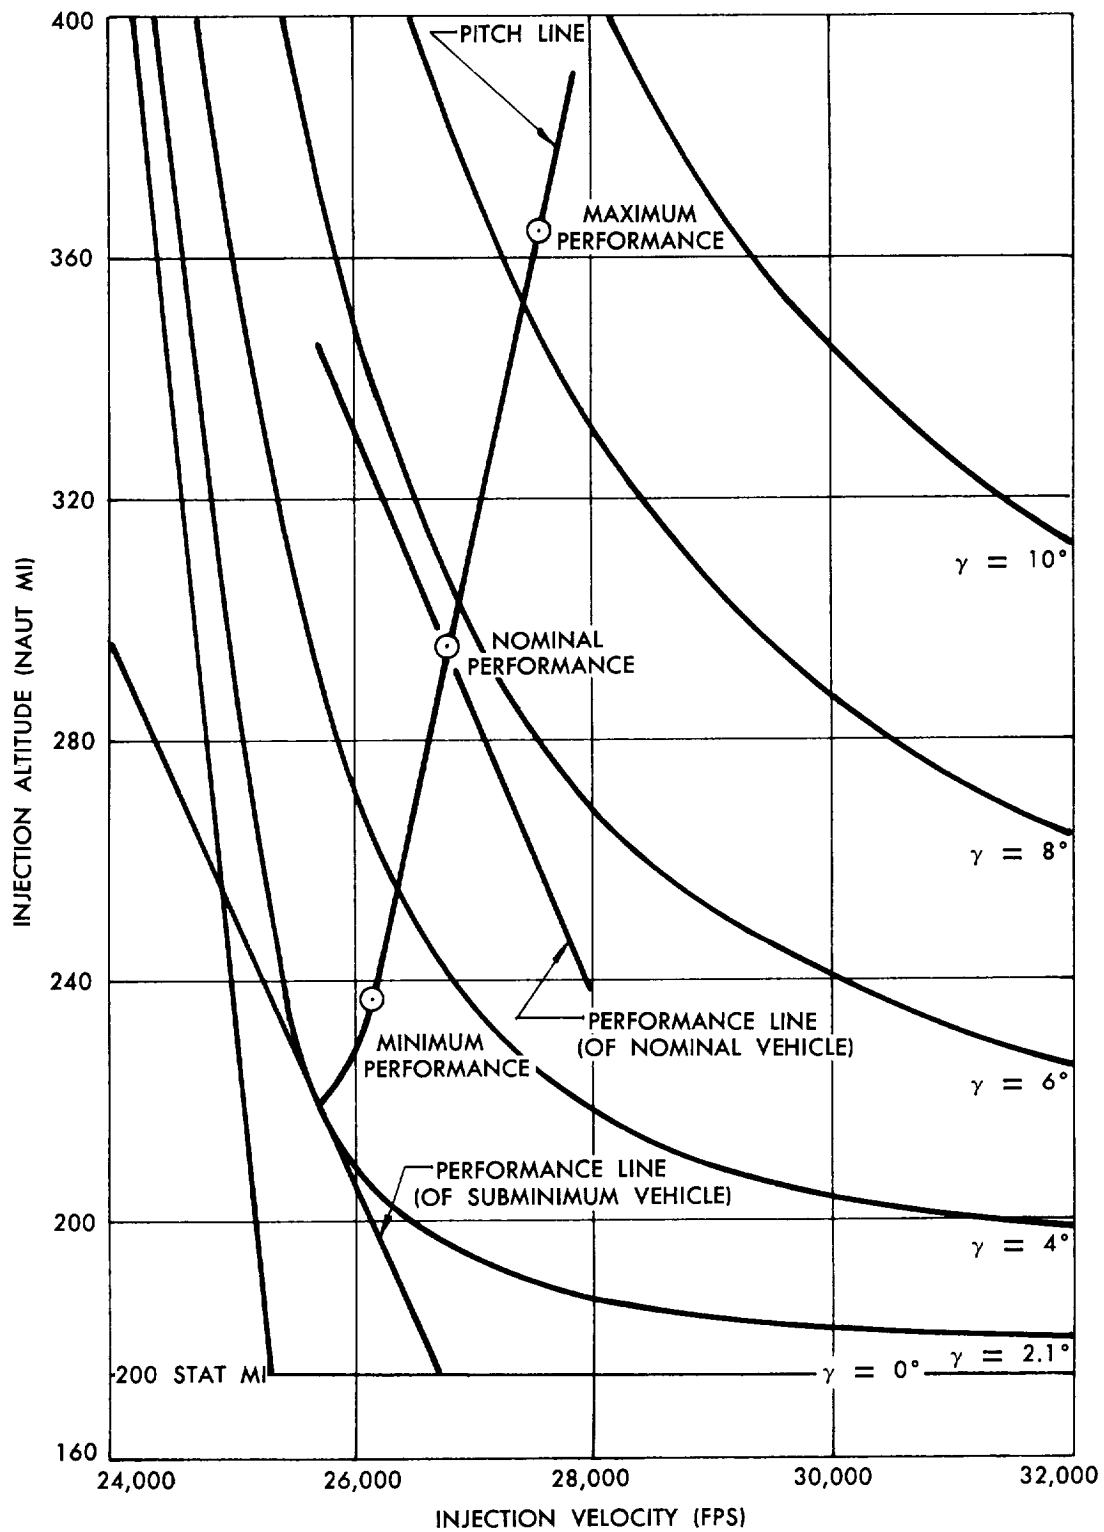
**Fig. 2 Performance Map for 200-Statute Mile Perigee Orbits**

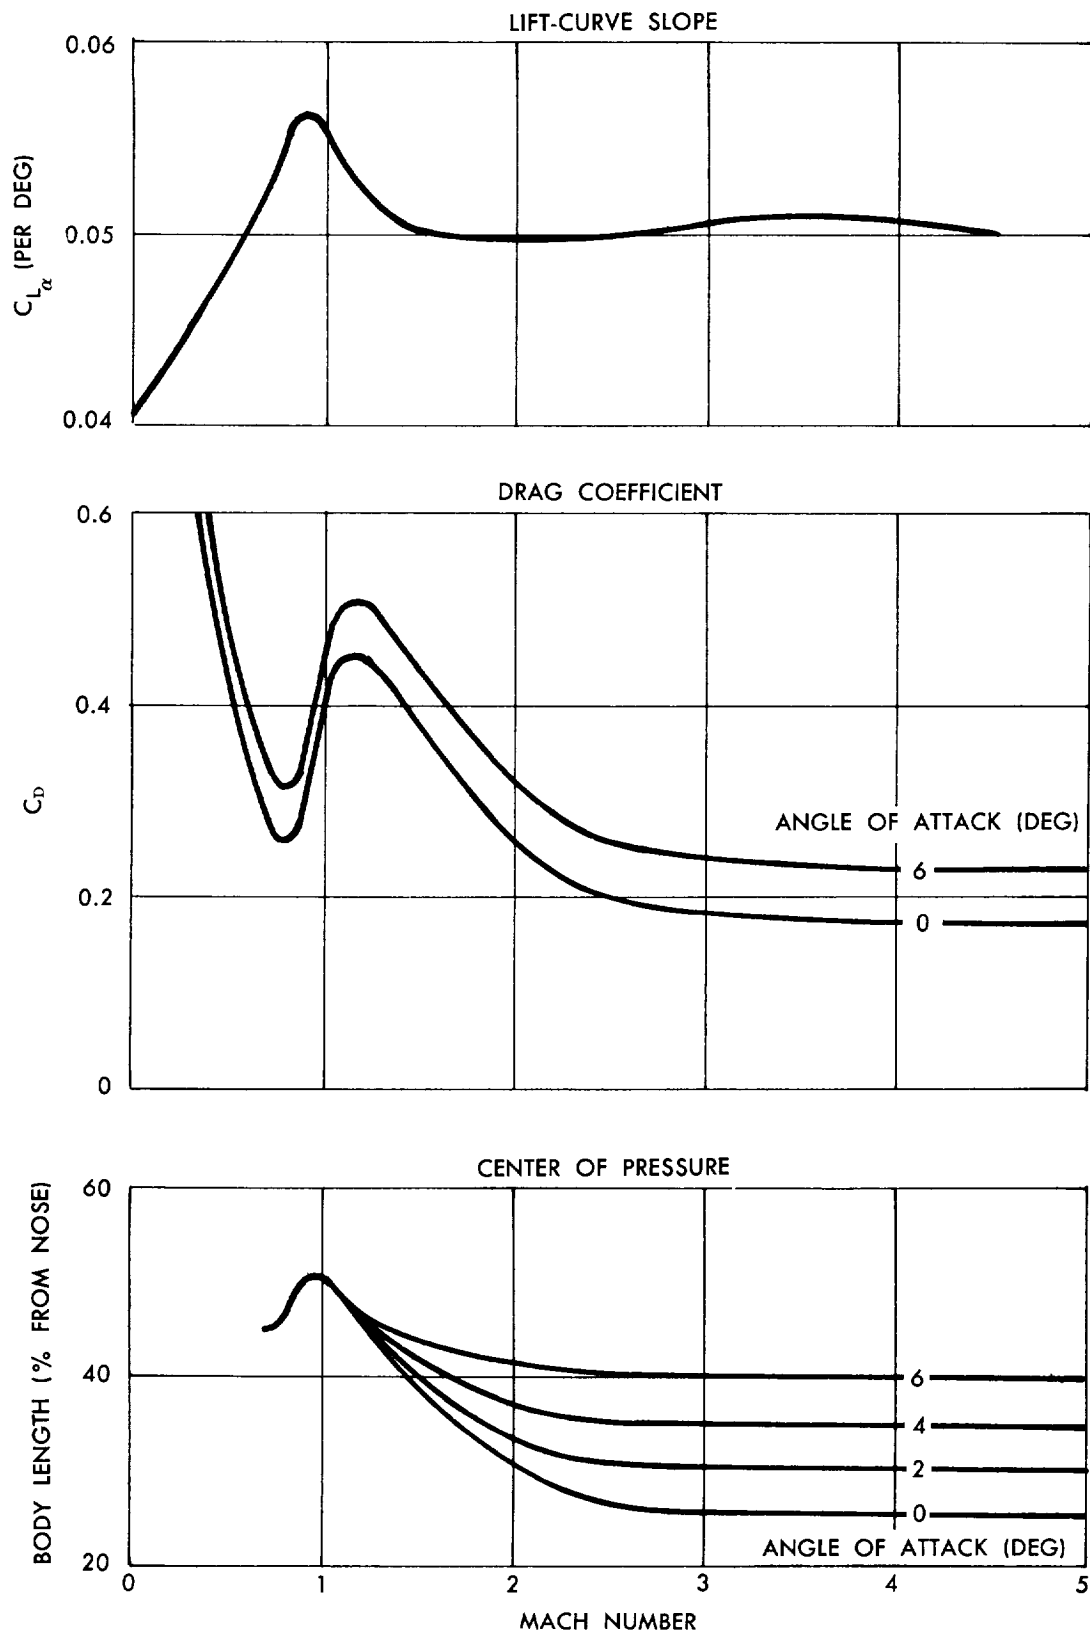
Fig. 3 Vehicle Lift, Drag Coefficient and Center of Pressure vs Mach Number

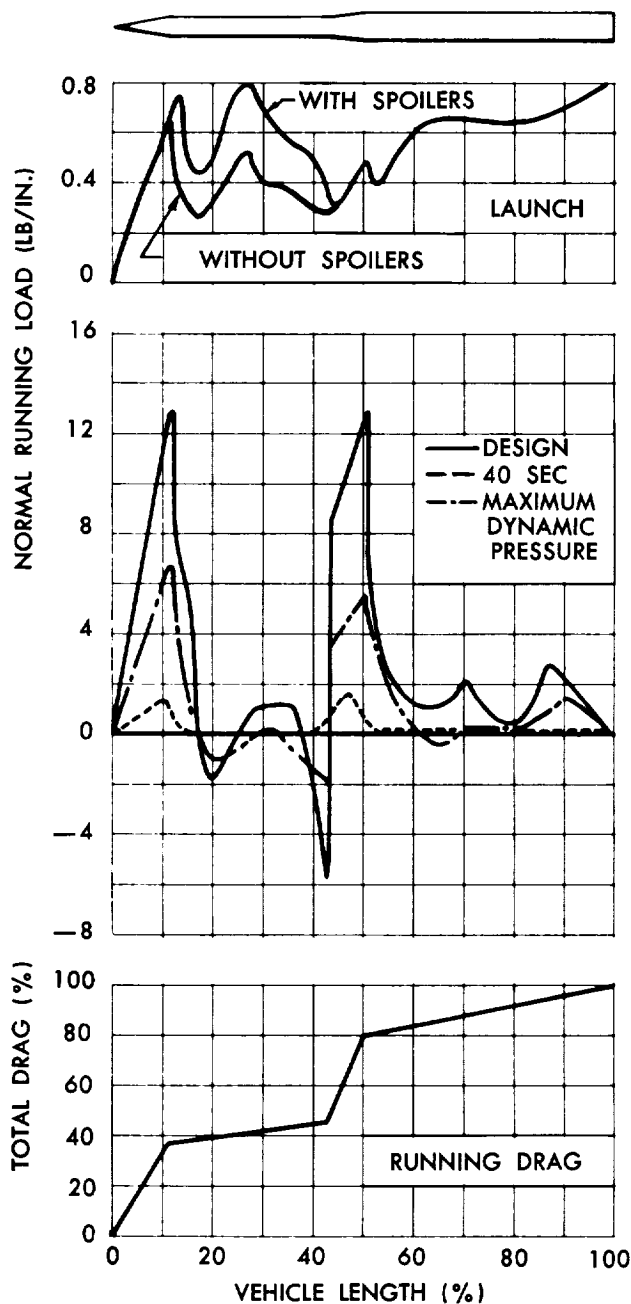
Fig. 4 Running Airloads

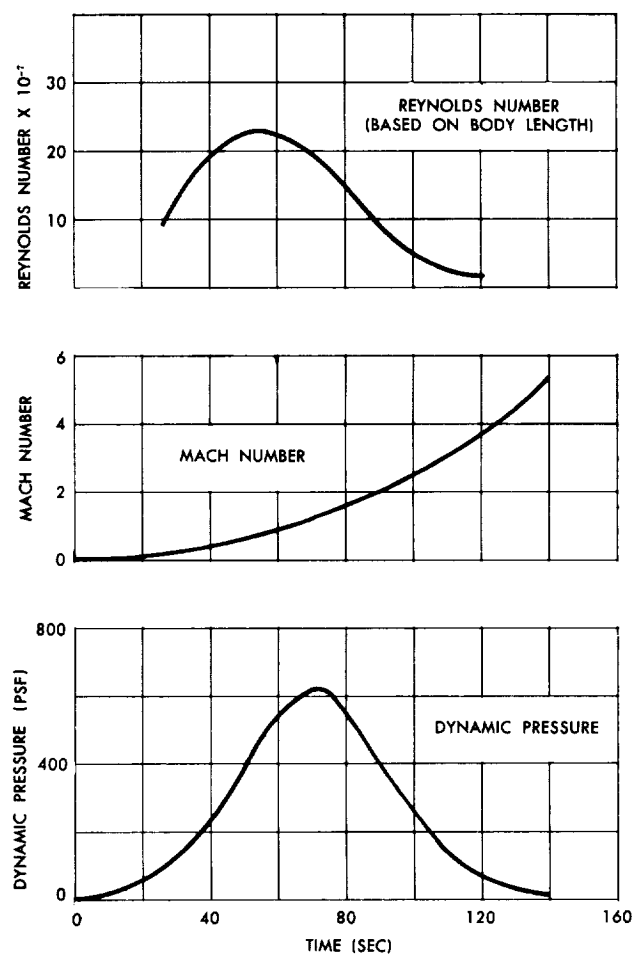
Fig. 5 Time Histories of the Design Reynolds Number, Mach Number and Dynamic Pressure

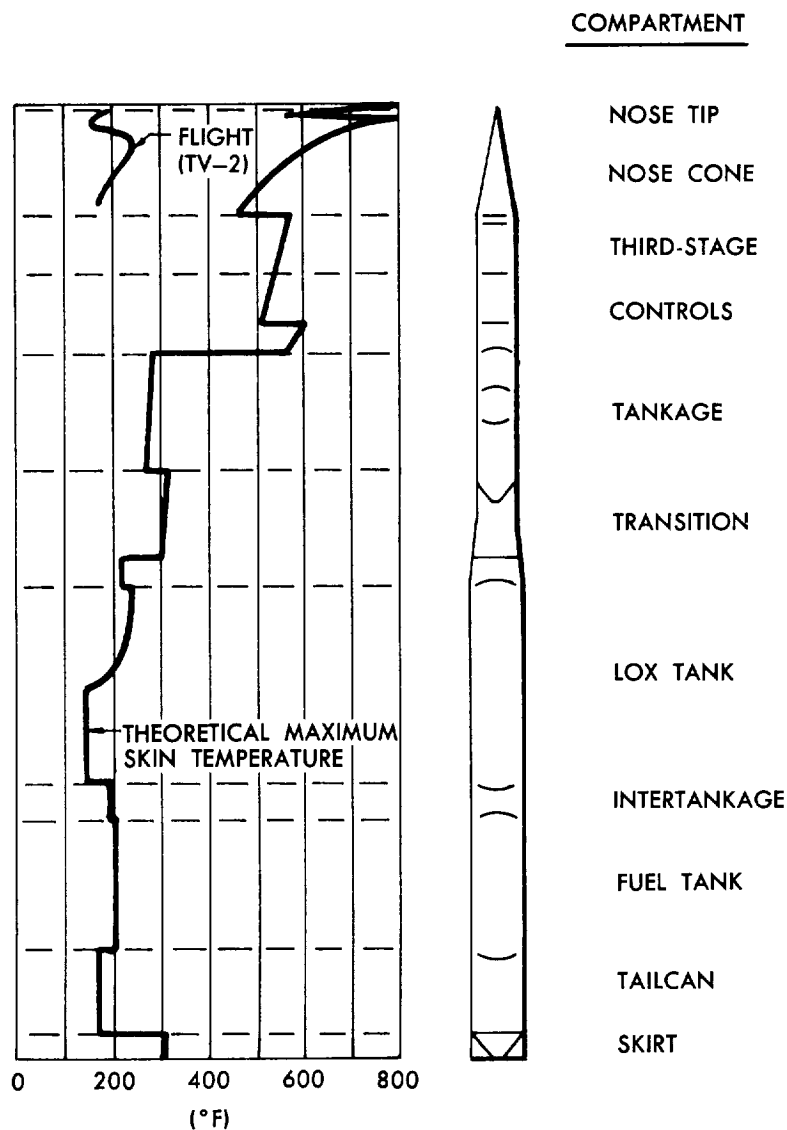
Fig. 6 Theoretical Maximum Skin Temperature due to Aerodynamic Heating

in actual flight and still permitted the use of reasonable materials and thicknesses. Calculations made by other methods for the heating of blunt bodies showed that the solid nose tip would not melt during ascent, that the outer skin of the satellite would not exceed 300°F if the nose cone were ejected 30 seconds after first-stage burnout, and that the antennas, heat shields and conduits were of sufficient strength to withstand the effects of aerodynamic heating. Further investigation revealed that no internal equipment would be damaged by heat transfer from the outer skin. The design maximum temperatures are shown in Fig. 6.

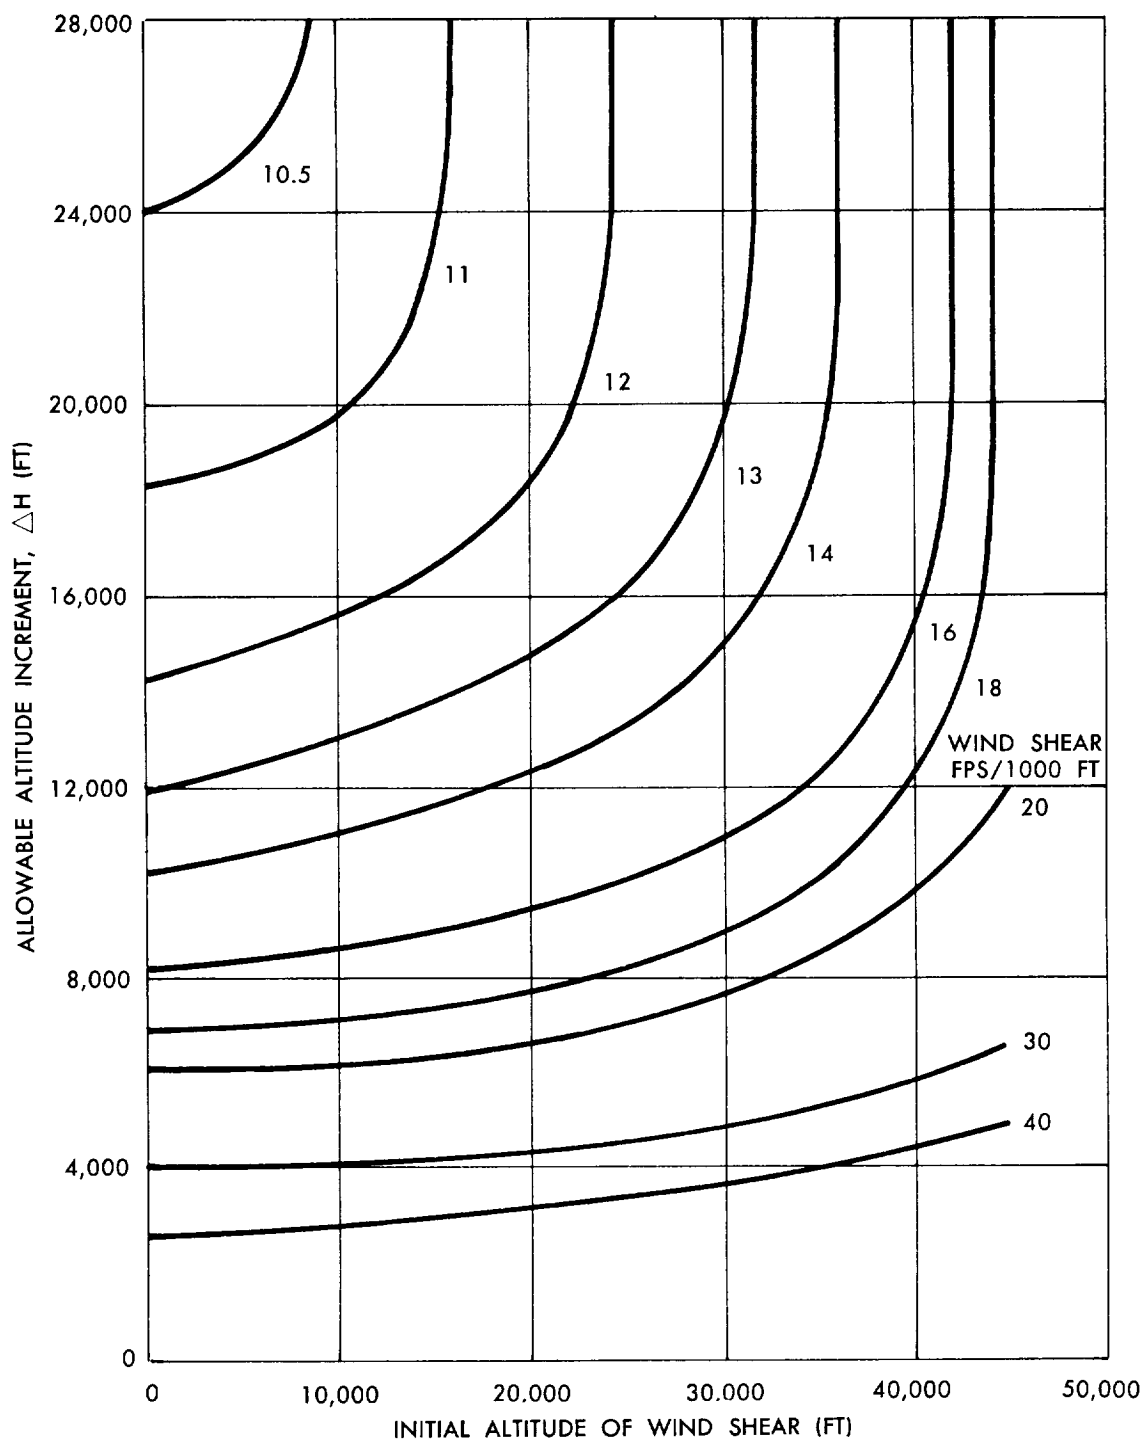
**Fig. 8 Maximum Allowable Wind Shear Duration — No Steady Winds**

Additional investigation of environmental conditions indicated that the critical gusts to be expected were about 20 fps instead of 40 fps. The specification was changed accordingly. In the winter of 1957, successful flights were made under wind shear conditions that had been previously considered marginal. This, coupled with an enhanced knowledge of the dynamic loads as a result of the TV-3BU flight malfunction investigation, and with revised estimates of the aerodynamic moments based on the SLV-1 flight, warranted re-examination of the wind shear criteria. This re-examination indicated that the vehicle was capable of withstanding about 30 percent higher continuous wind shears than those previously defined. The wind shear criteria as modified to agree with these relaxed requirements are shown in Fig. 8.

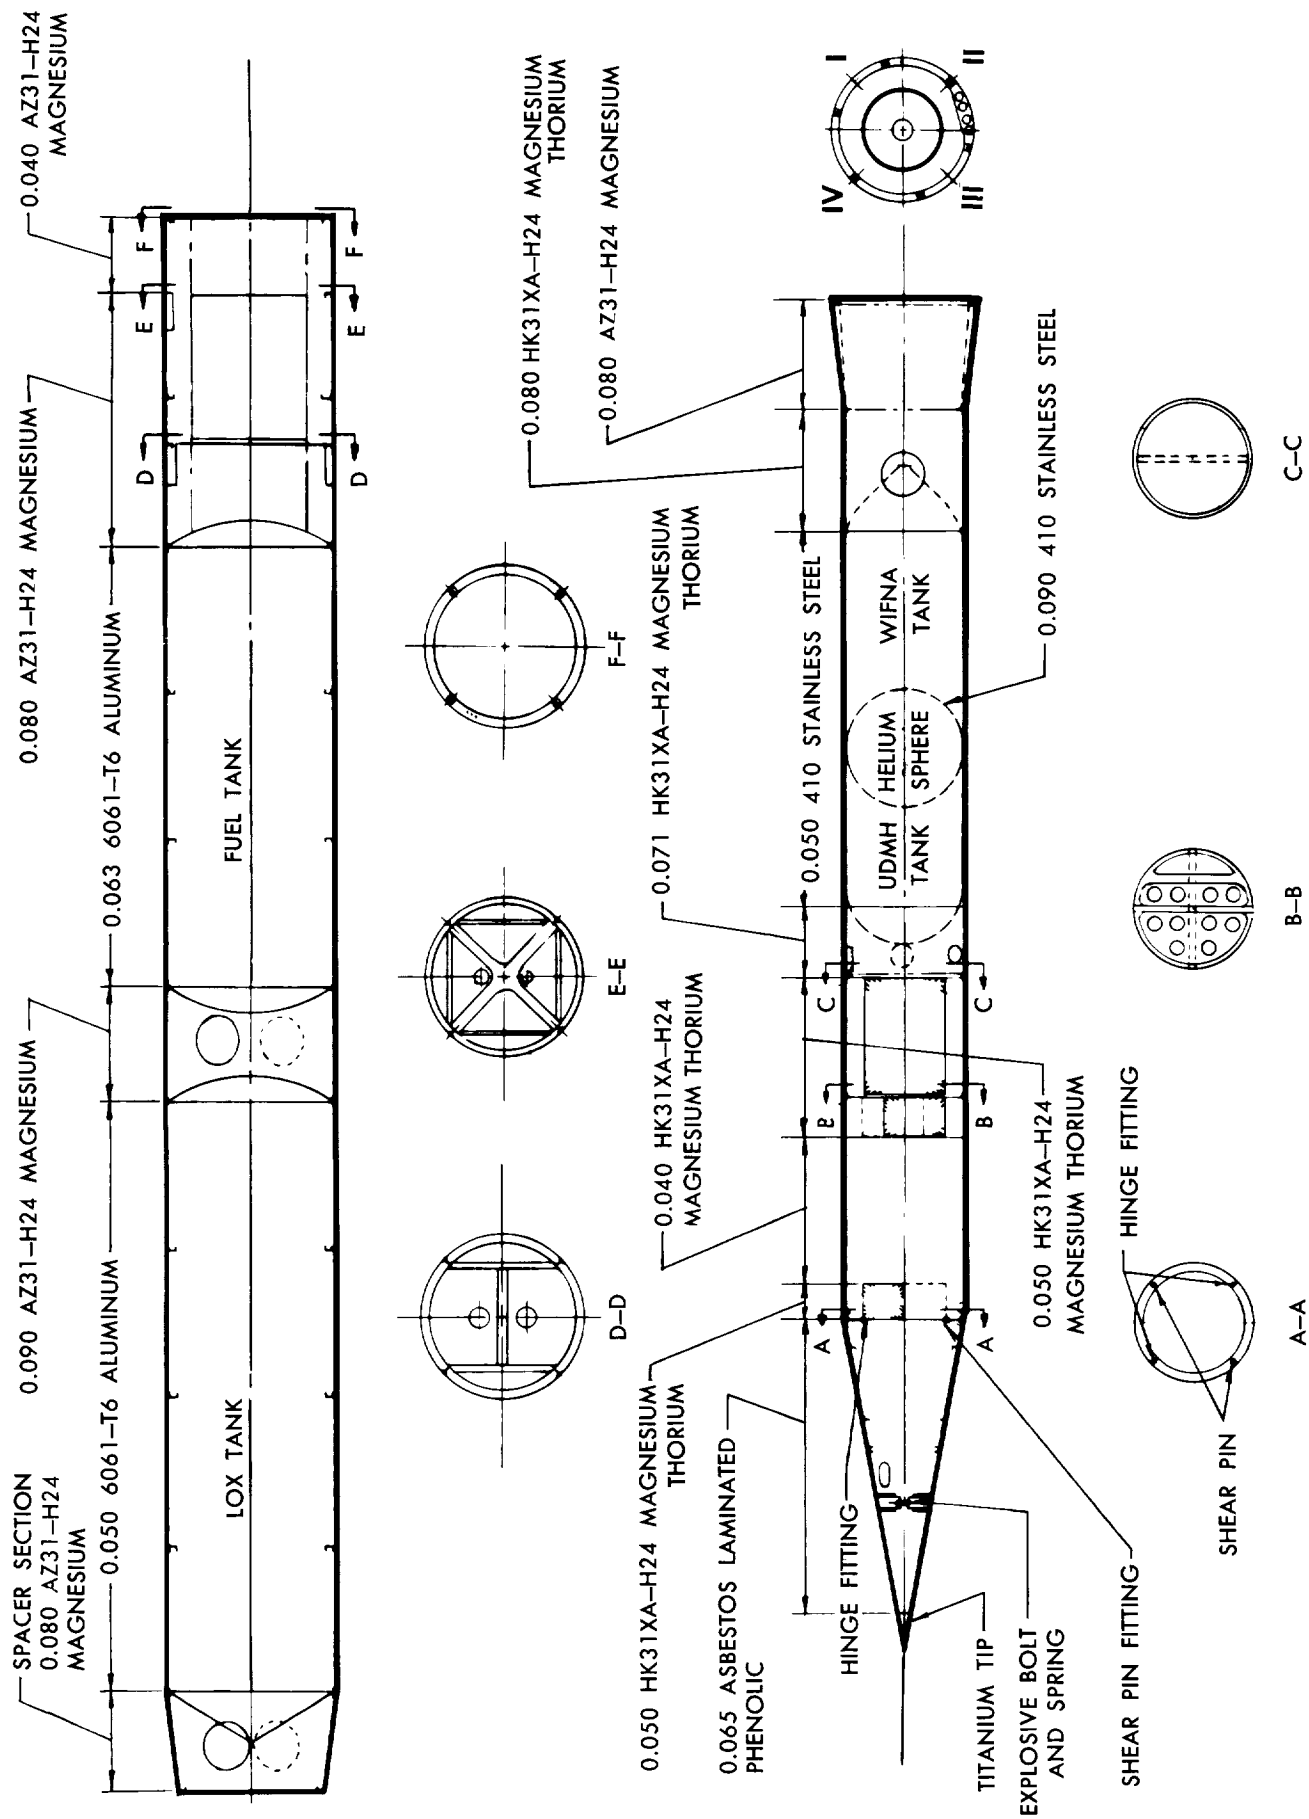
Fig. 9 Vanguard Primary Structure

The propellant tankage was a 410 corrosion-resistant steel integral structure, consisting of a 0.050-inch thick monocoque oxidizer tank with a "conuckle" shaped aft dome and a 0.050-inch thick monocoque fuel tank with a hemispherical forward dome, joined together by a 32-inch diameter, 0.090-inch thick helium sphere.

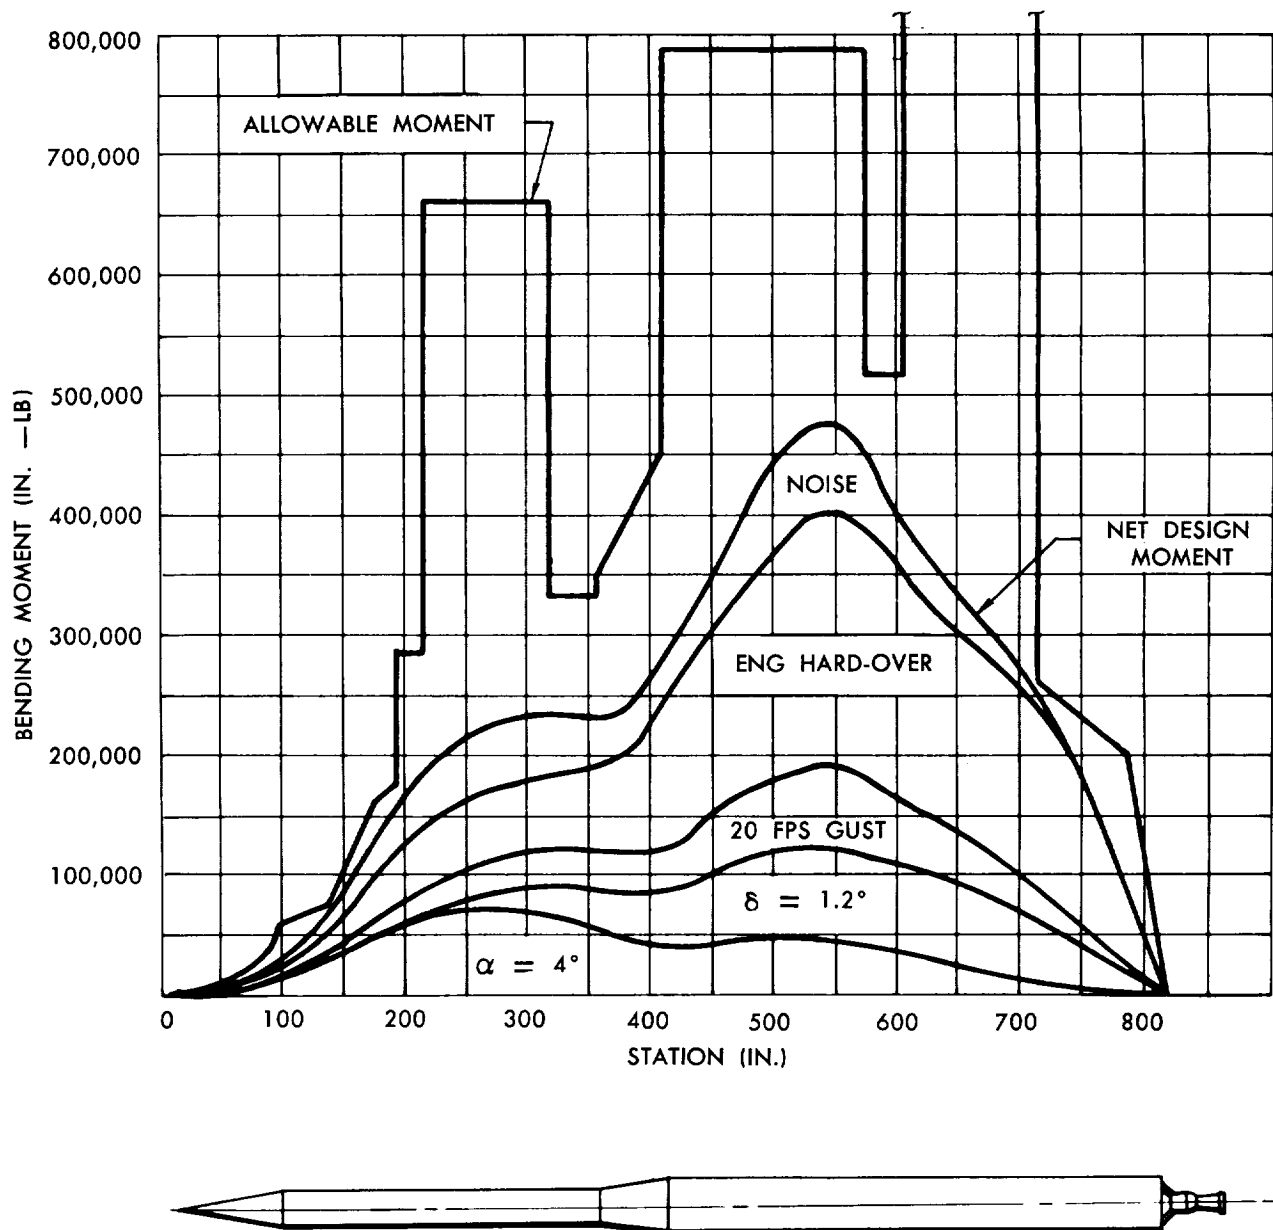
Fig. 10 Design Limit Bending Moment at Maximum Dynamic Pressure

The various structural loads were superimposed (Fig. 10) in order to determine the total load on the structure. That is, the maximum bending moments due to wind shear transients, motor hard-over and engine noise were assumed to occur simultaneously, and were assumed to be added to the flight static loads. The launch condition assumed the superposition of the misalignment, motor hard-over, engine noise and static loads. This conservative approach was adopted for the Vanguard because of insufficient data on local wind shear gradients and their distribution. The probability of a control system malfunction in which the motor moved hard-over to its limits and returned in time to regain control was not studied. A more sophisticated approach would have been to determine the probability of occurrence of the various loads at some given instant. This approach could have been used if sufficient statistical data of the required type had been available.

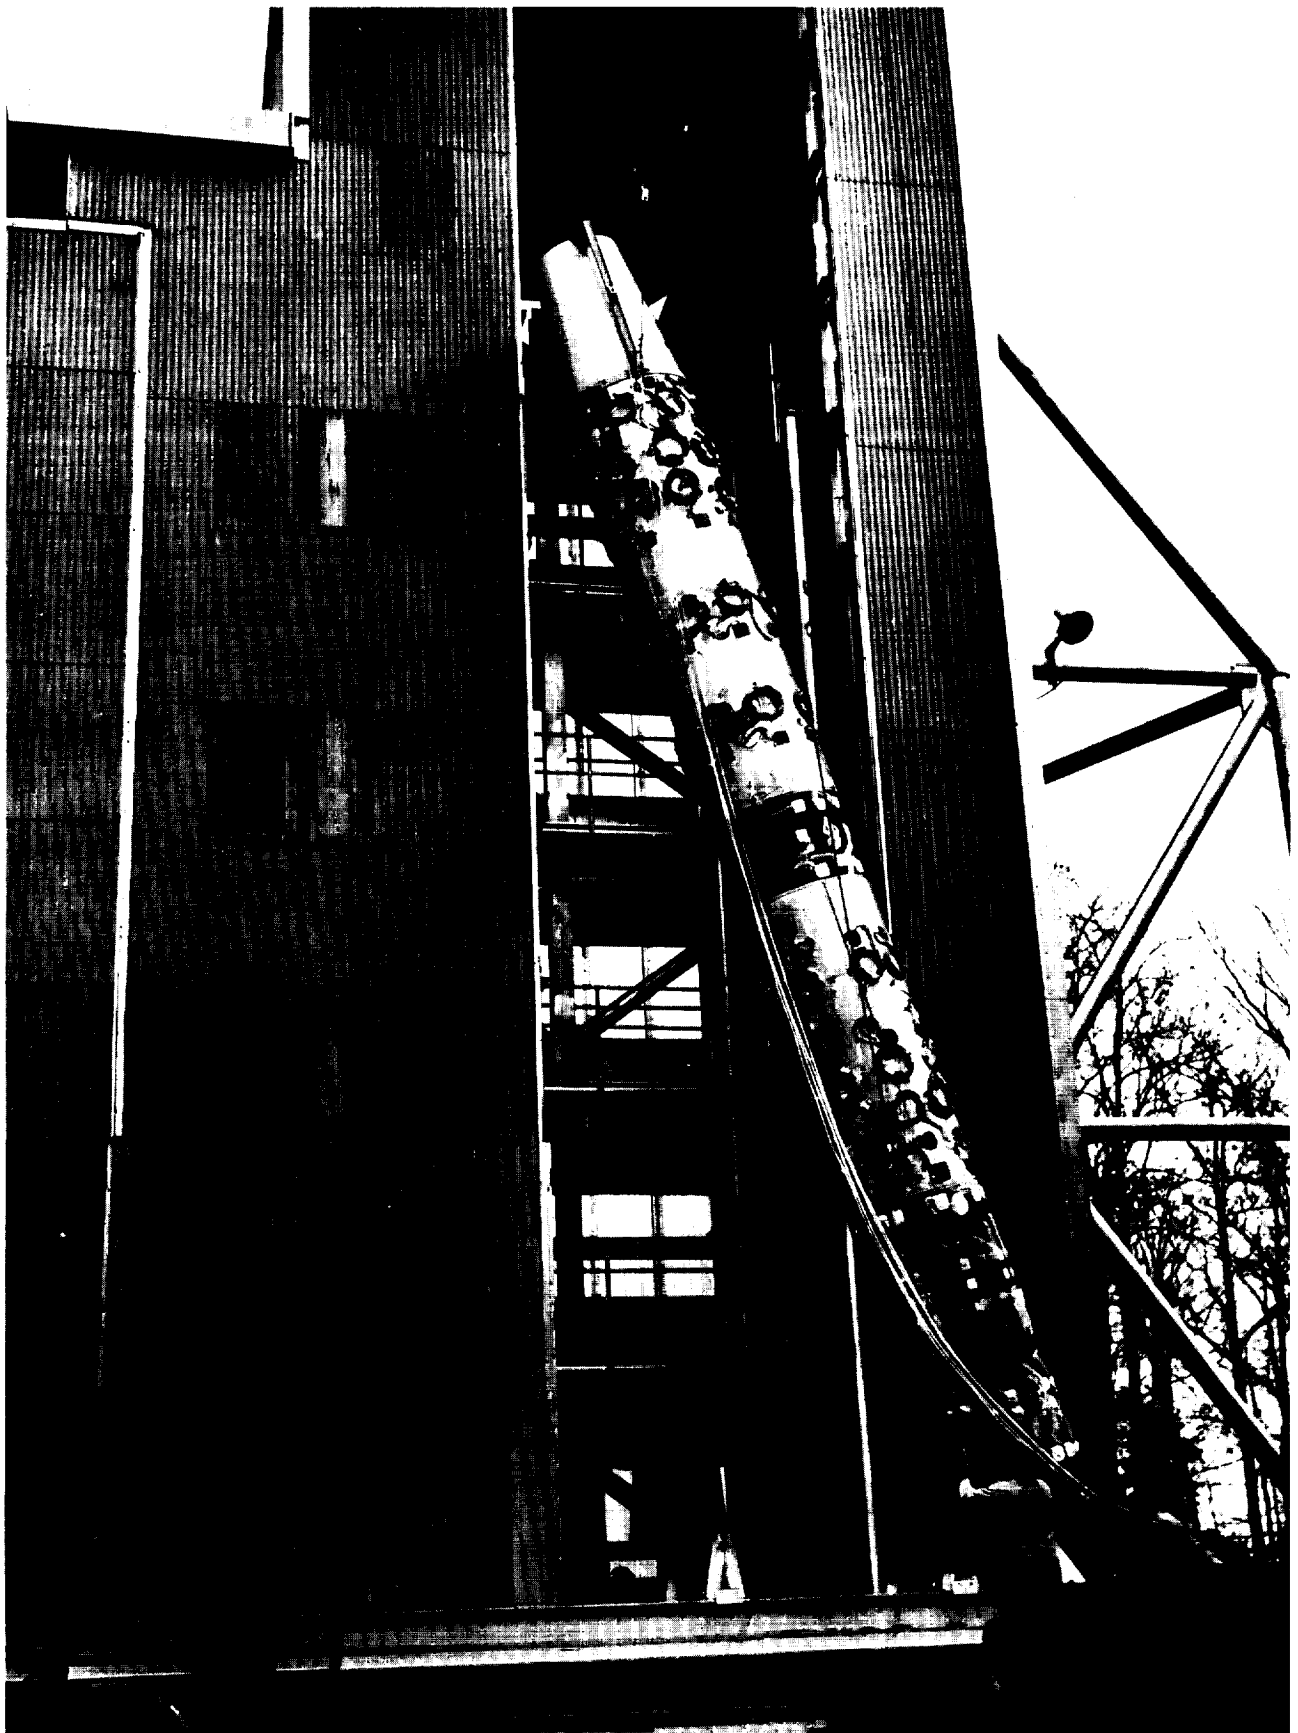
**Fig. 11 Structural Test Fixture**

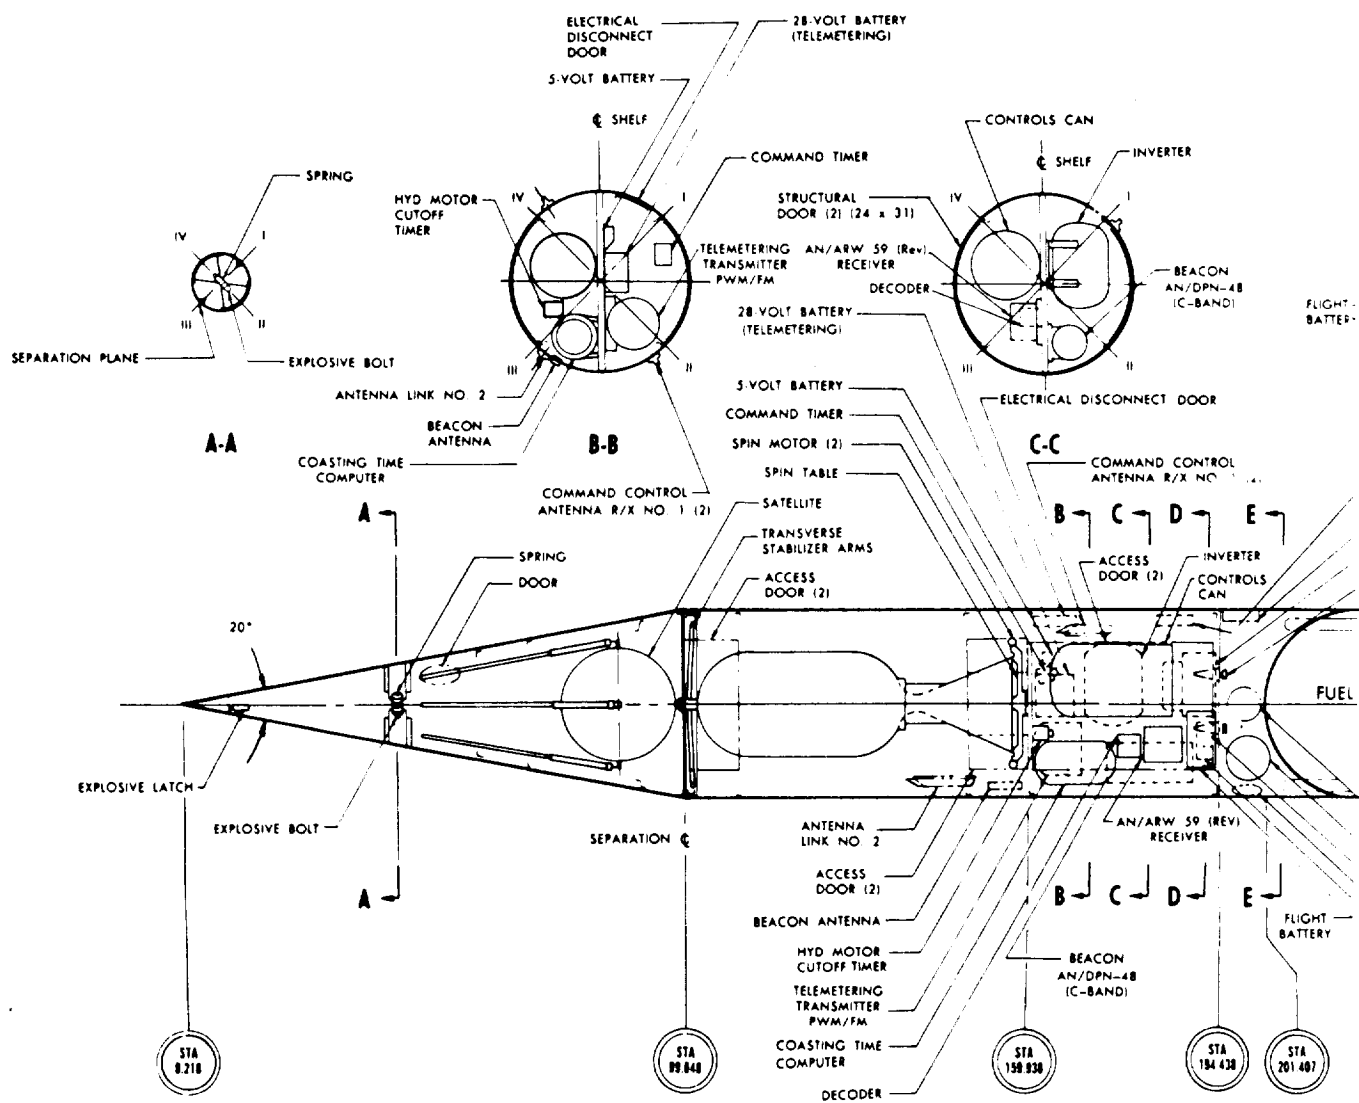
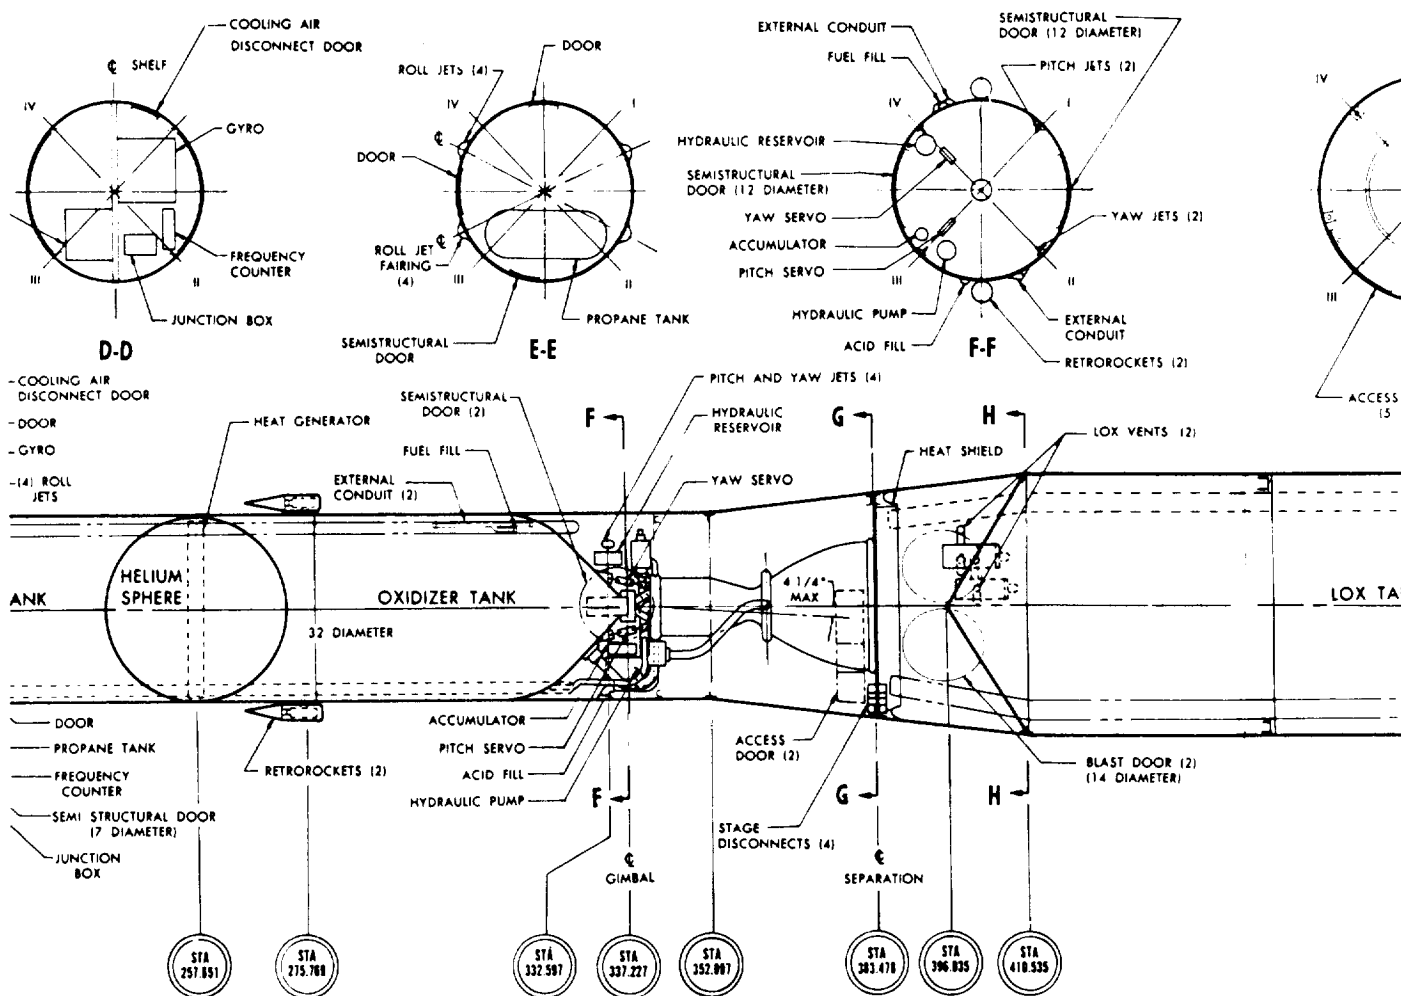
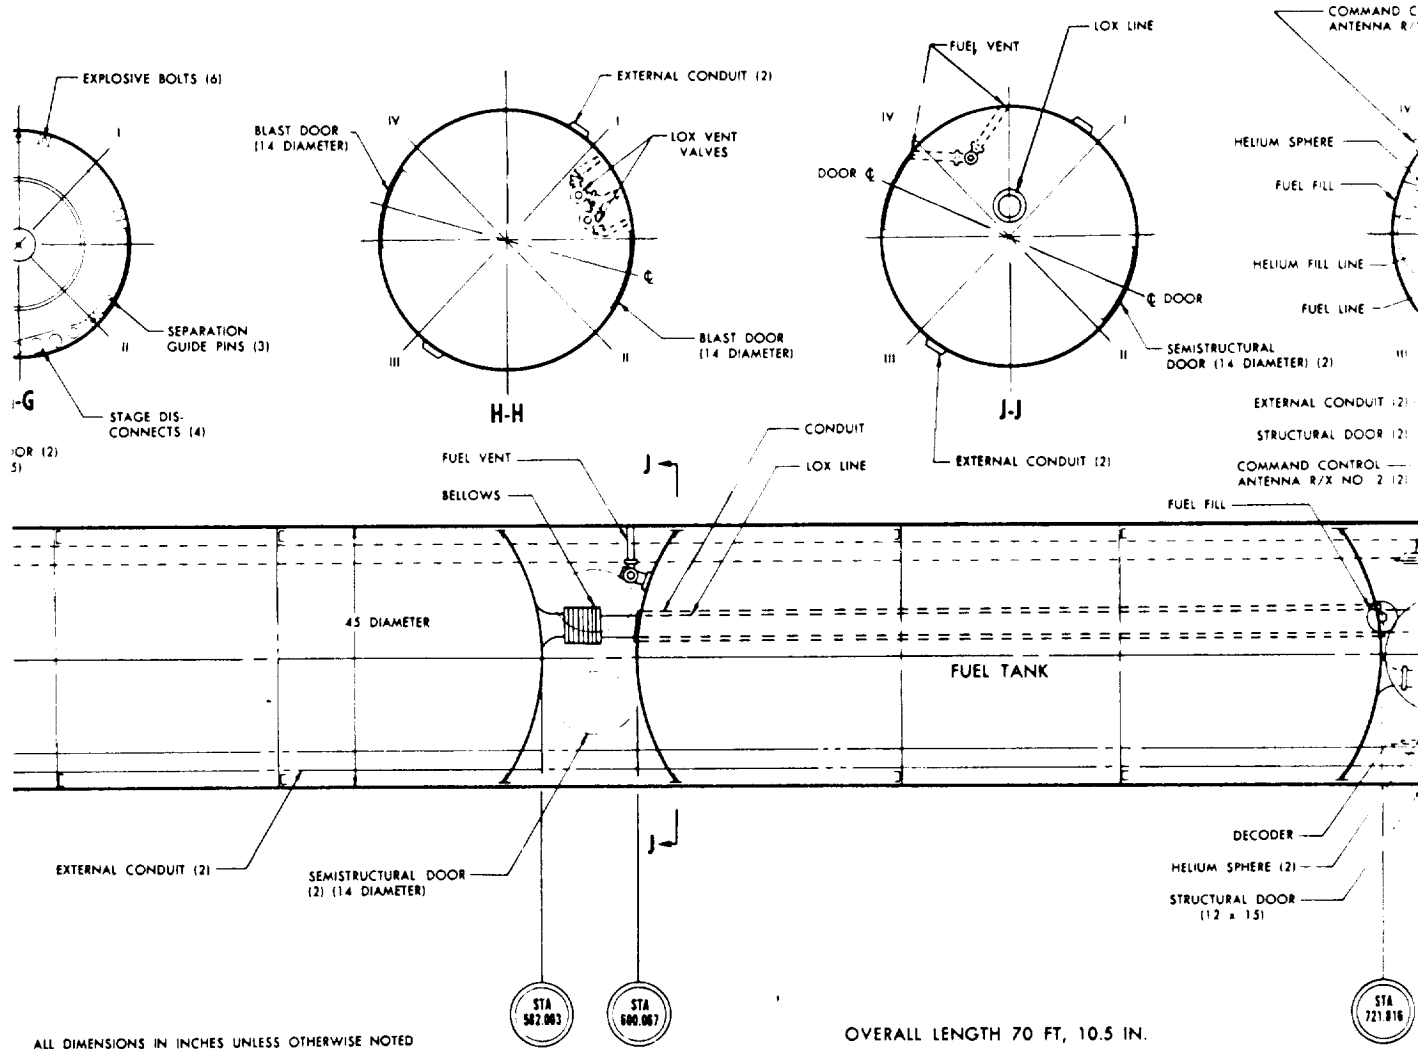
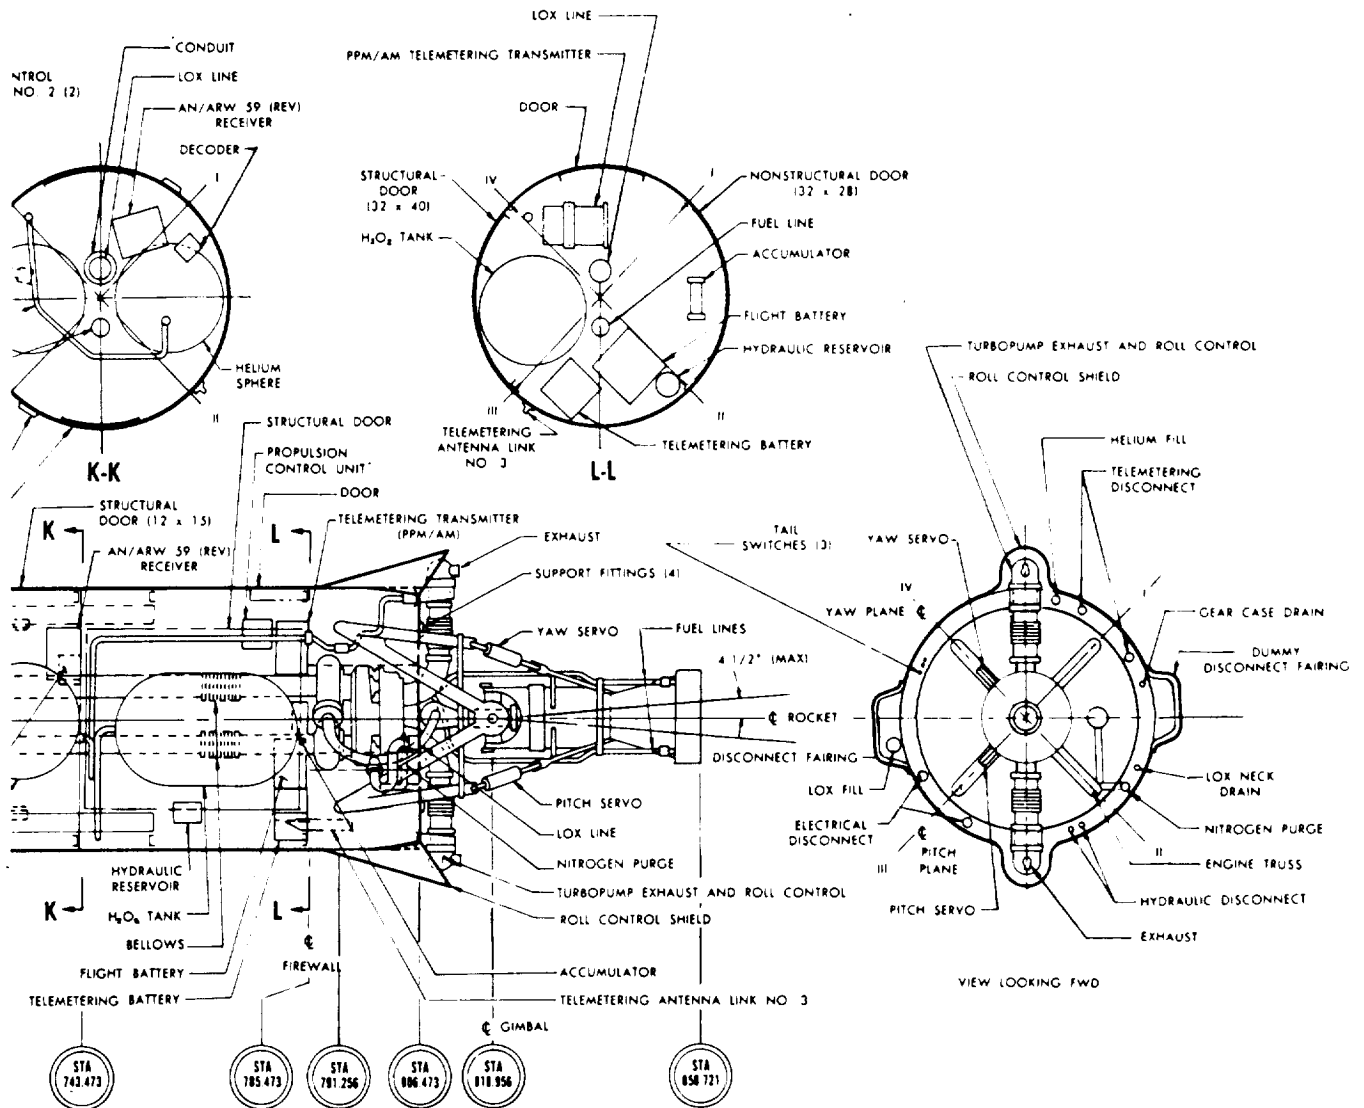
Fig. 12. Inboard Profile

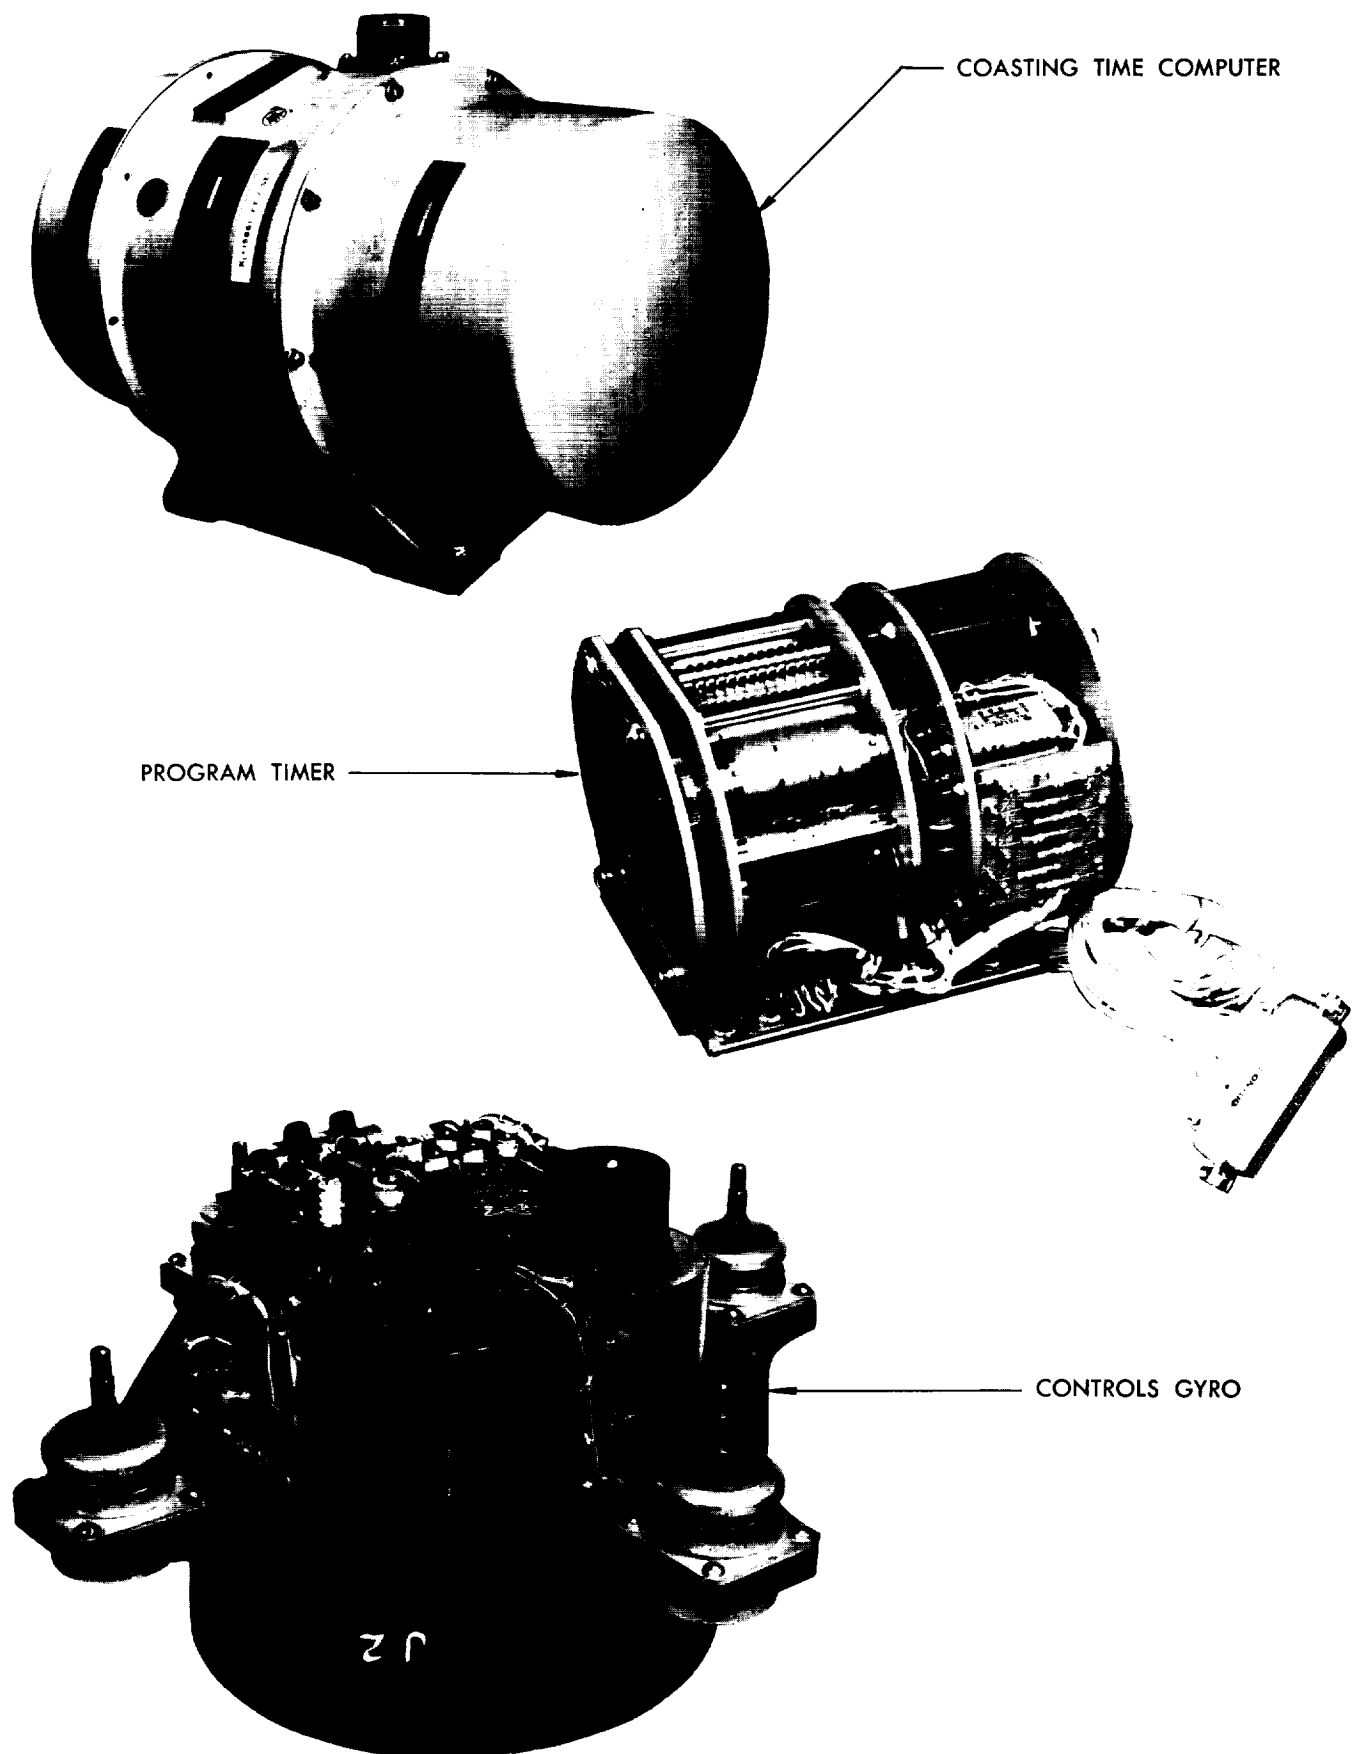
**Fig. 13 Major Components, Airborne Guidance System**
